SHERMAN, CONNECTICUT

LAKE MAUWEEHOO DAM

CT 00321

PHASE I INSPECTION REPORT

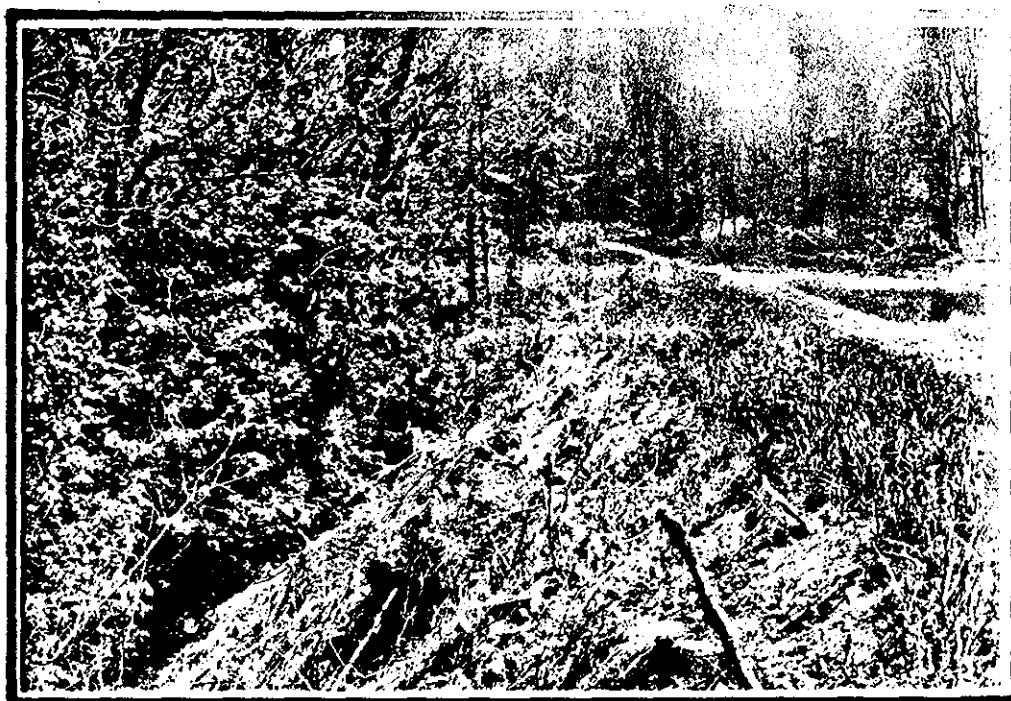
LAKE MAUWEEHOO DAM - DOWNSTREAM FACE

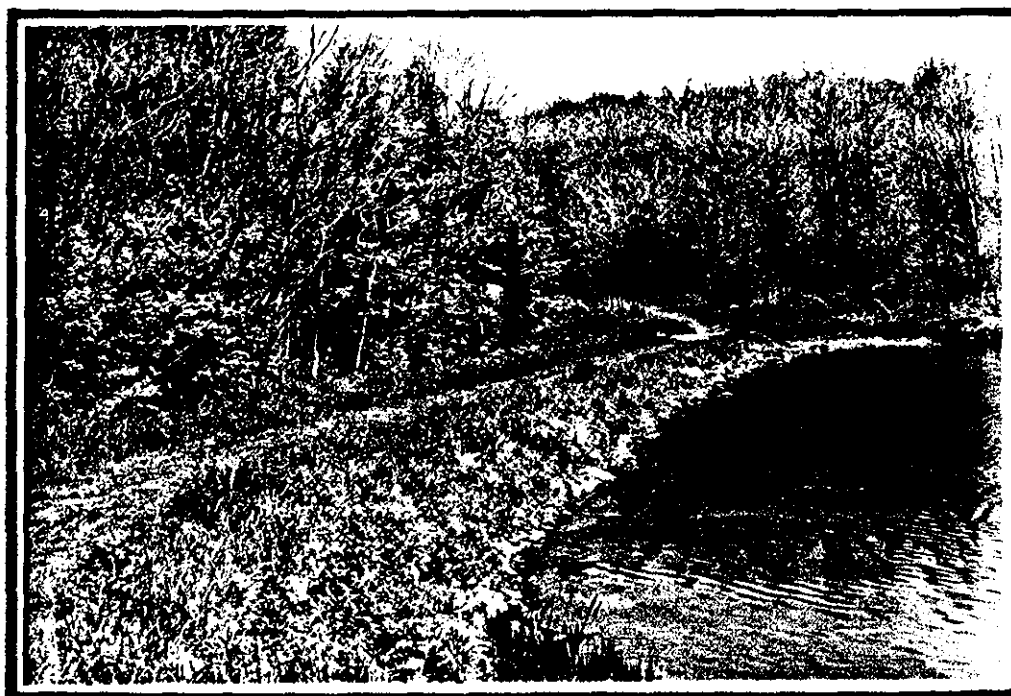
: UPSTREAM FACE

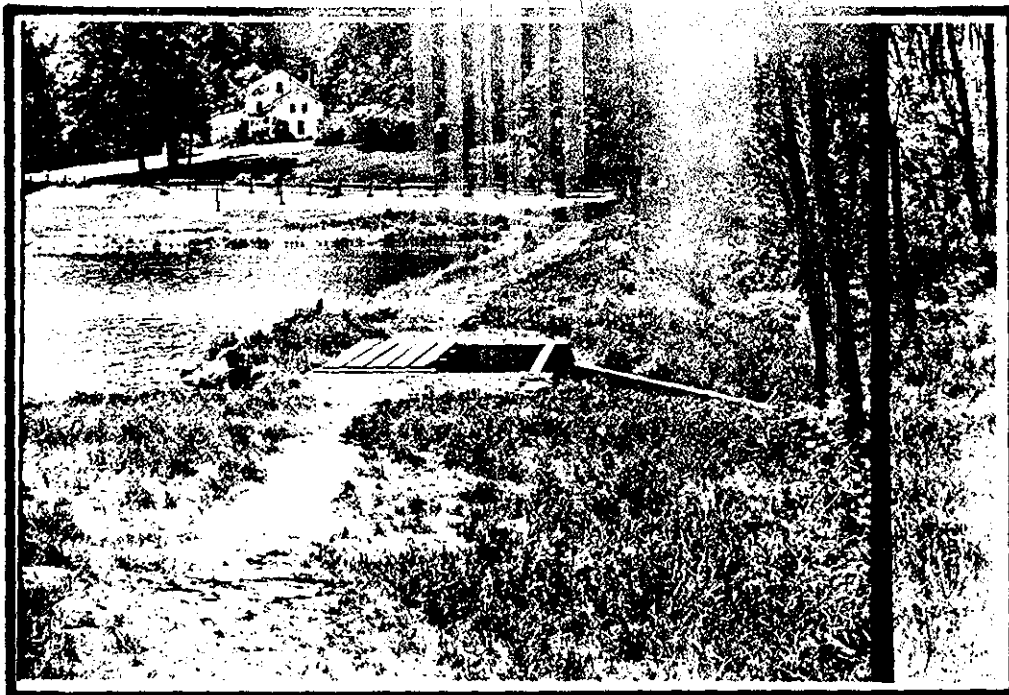
CREST OF DAM
EMERGENCY SPILLWAY - PRINCIPAL SPILLWAY

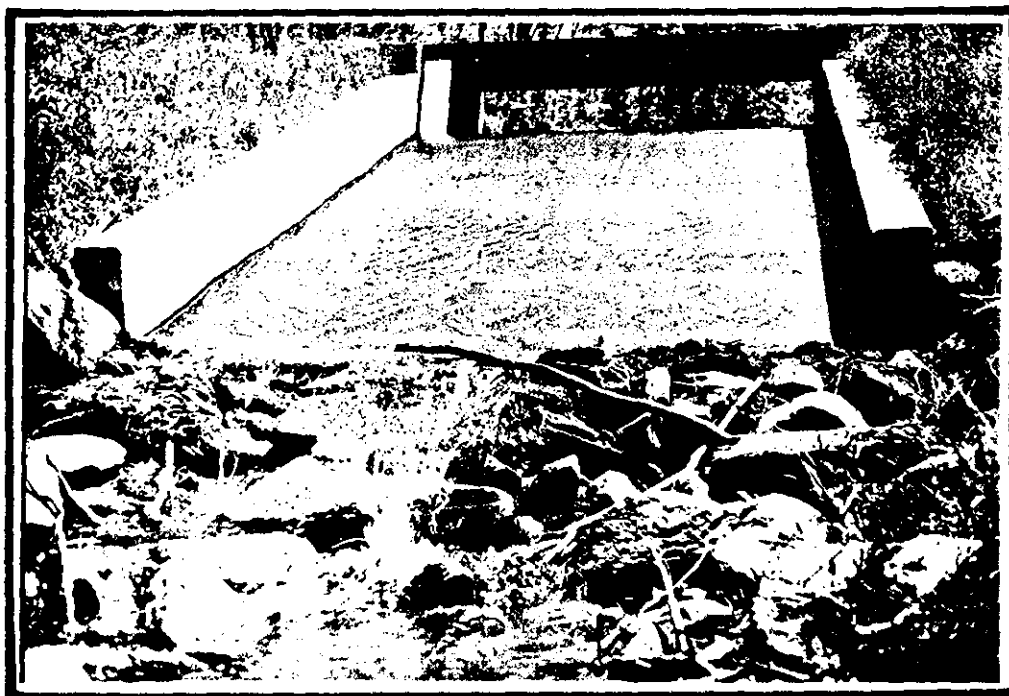
: PRINCIPAL SPILLWAY
